Field Service Bulletin No. 45 for

ADC Compact

New material for scan rollers introduced (CM+9.5145.2650.1)

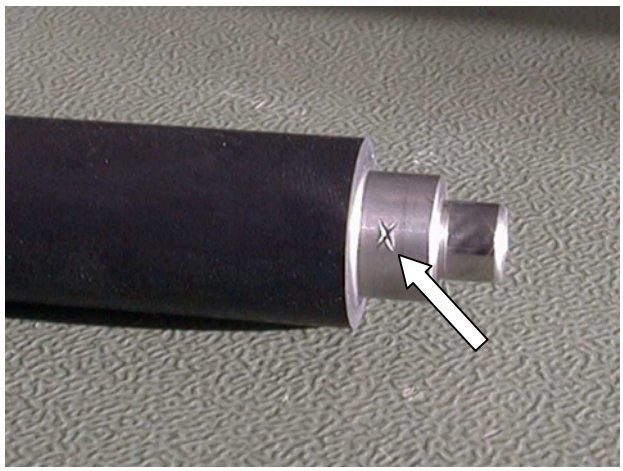
The surface of the IP may show black stripes caused by diffusion at the scan rollers. This was noticed especially with new machines. The effect diminishes when the digitizer has been in use for several months.

If this abrasion stays on the scan rollers for a longer time, the used IPs may become damaged (chemical changes of the material).

Exchange the scan rollers. A new material for the scan rollers has been introduced.
These altered scan rollers are marked with an "X", see figure beside.

CM+9.5145.2650.1	Scan rollers with new material

If the IPs of a system are exchanged because of the damages described above, it is highly recommended to exchange the scan rollers as well.
